## Little Traverse Bay Watershed Road/Stream Crossing Inventory

Completed by Tip of the Mitt Watershed Council with support from:  
Petoskey-Harbor Springs Area Community Foundation's  
*Little Traverse Bay Protection and Restoration Fund*

February 2014

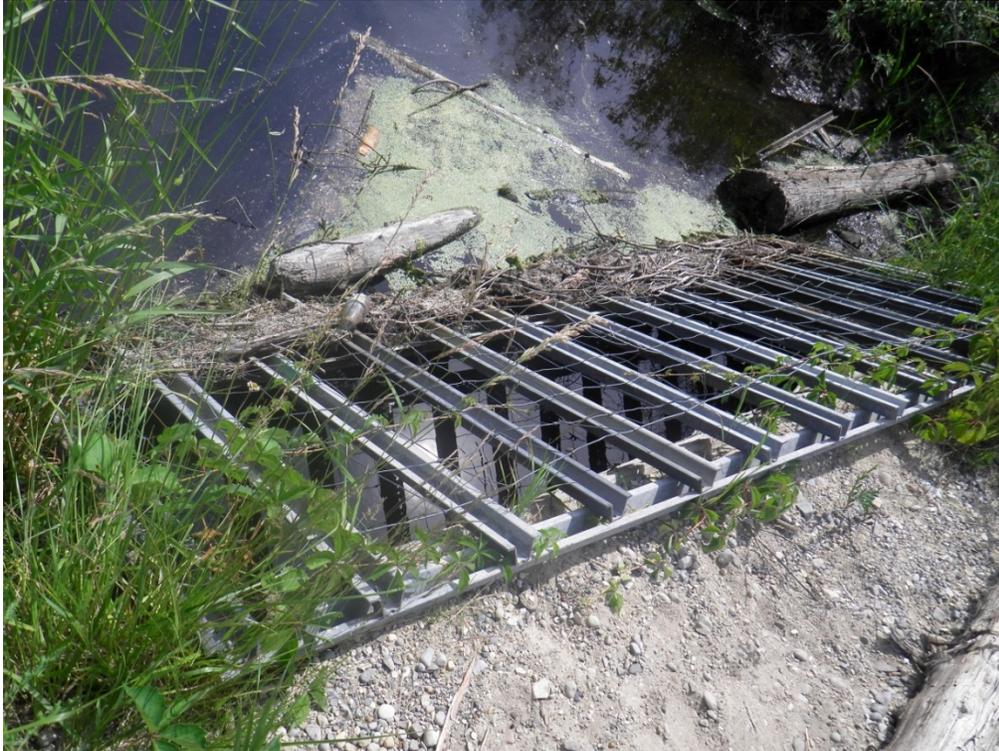
Current conditions include one, four ft. wide wooden culvert of unknown age. The structure is failing, too narrow for the crossing, and partially crushed. Although the road is paved, the gravel shoulder is continually eroding into the stream. Total erosion is calculated as contributing less than one ton of sediment/year, although more sediment is suspected of entering the stream than what is estimated. Results from the Fineout and Schoof's Creek Monitoring Study (TOMWC, 2013) suggest the RSX may be contributing to lower oxygen levels and high water temperatures in the lower reach of the stream. The adjoining land use consists of high-quality wetlands. The WLTC owns and manages three preserves adjacent to the RSX, totaling over 33 acres of protected lands. They also recently acquired 50 additional acres upstream of the RSX that will protect the wetland corridor which feeds Fineout Creek. These high-quality wetlands and riparian habitat are an important component of the Walloon Lake and Bear River fisheries.

- Erosion (tons/year): .76
- Fish Passage Determination: .9
- Extent of Erosion: Very severe
- Severity Calculation: Severe

**Figure 3: Fineout Creek at Shadow Trails Dr. Stream inlet.**

- Replace existing timber bridge/culvert structure with new 24-foot span by 6-foot rise precast concrete box culvert. Restore existing paved approaches (50' each side of crossing). Locate new crossing just west of existing. Maintain flows through existing during construction. Temporary sheeting to isolate new culvert location during construction.

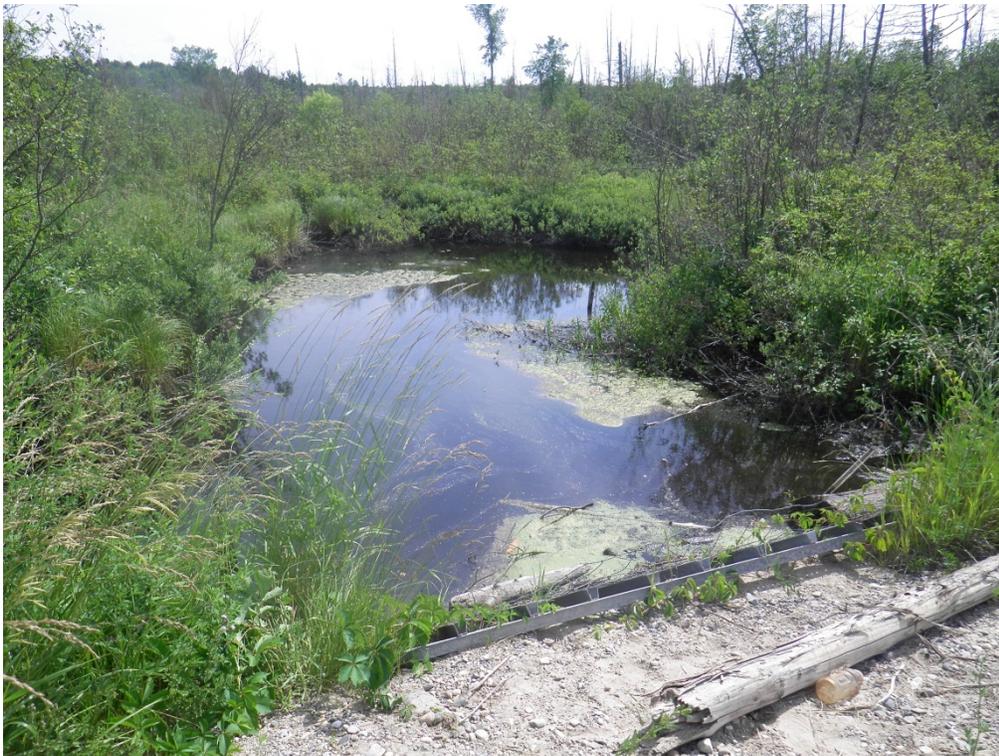
**Figure 4: Fineout Creek at Shadow Trails Dr. Upstream view.**

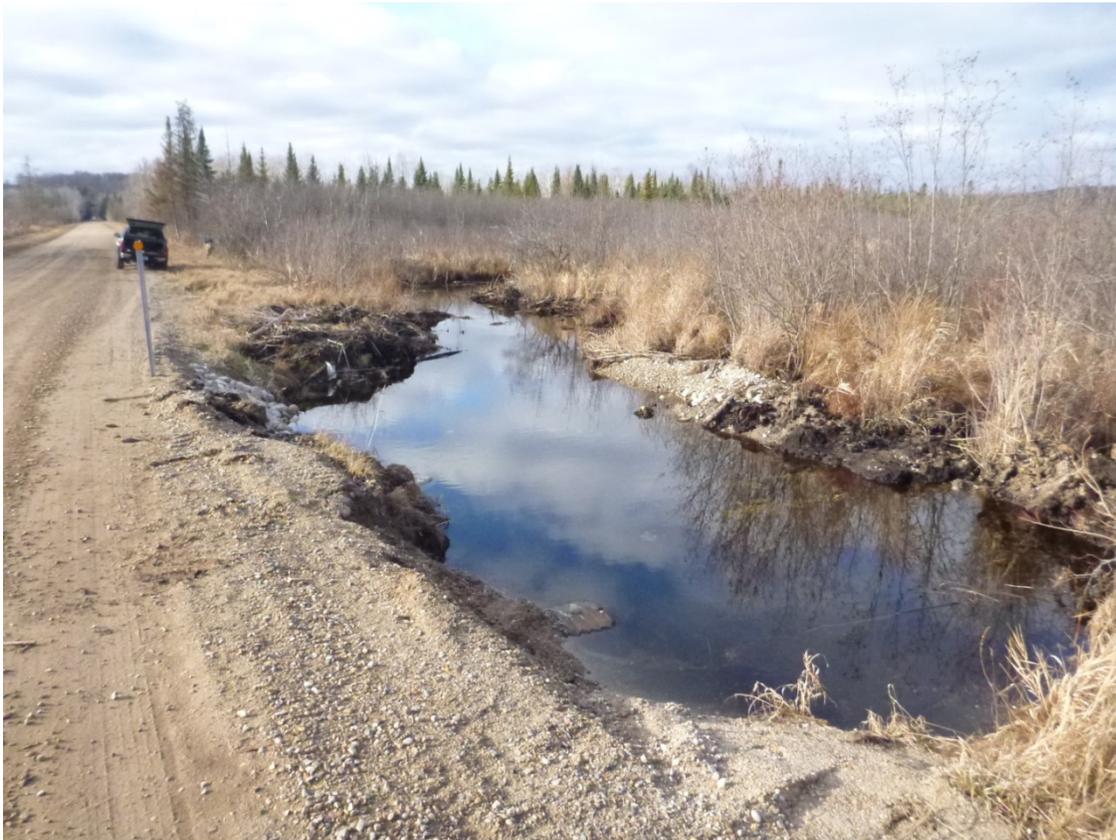
Current conditions include two very undersized, metal culverts that are nearly completely submerged even during low flow. The stream channel has migrated over time and is intersecting with the road at an angle that is exacerbating erosion; severe erosion of the roadbed is occurring on both sides of the crossing. No roadside vegetation is present to help intercept runoff as the road width is narrow. The road bisects the wetland complex, thereby interrupting hydrology and biological processes.

- Erosion (tons/year): 9+
- Fish Passage Determination: .9
- Extent of Erosion: Severe
- Severity Calculation: Severe

**Figure 5: Haymarsh Creek at Bauman Rd. Downstream view.**

- Replace two corrugated metal pipe (CMP) culverts with new 24-foot span by 6-foot rise precast concrete box culvert. Pave approaches (100' each side of crossing). Locate new crossing just west of existing. Maintain flows through existing during construction. Temporary sheeting to isolate new culvert location during construction.

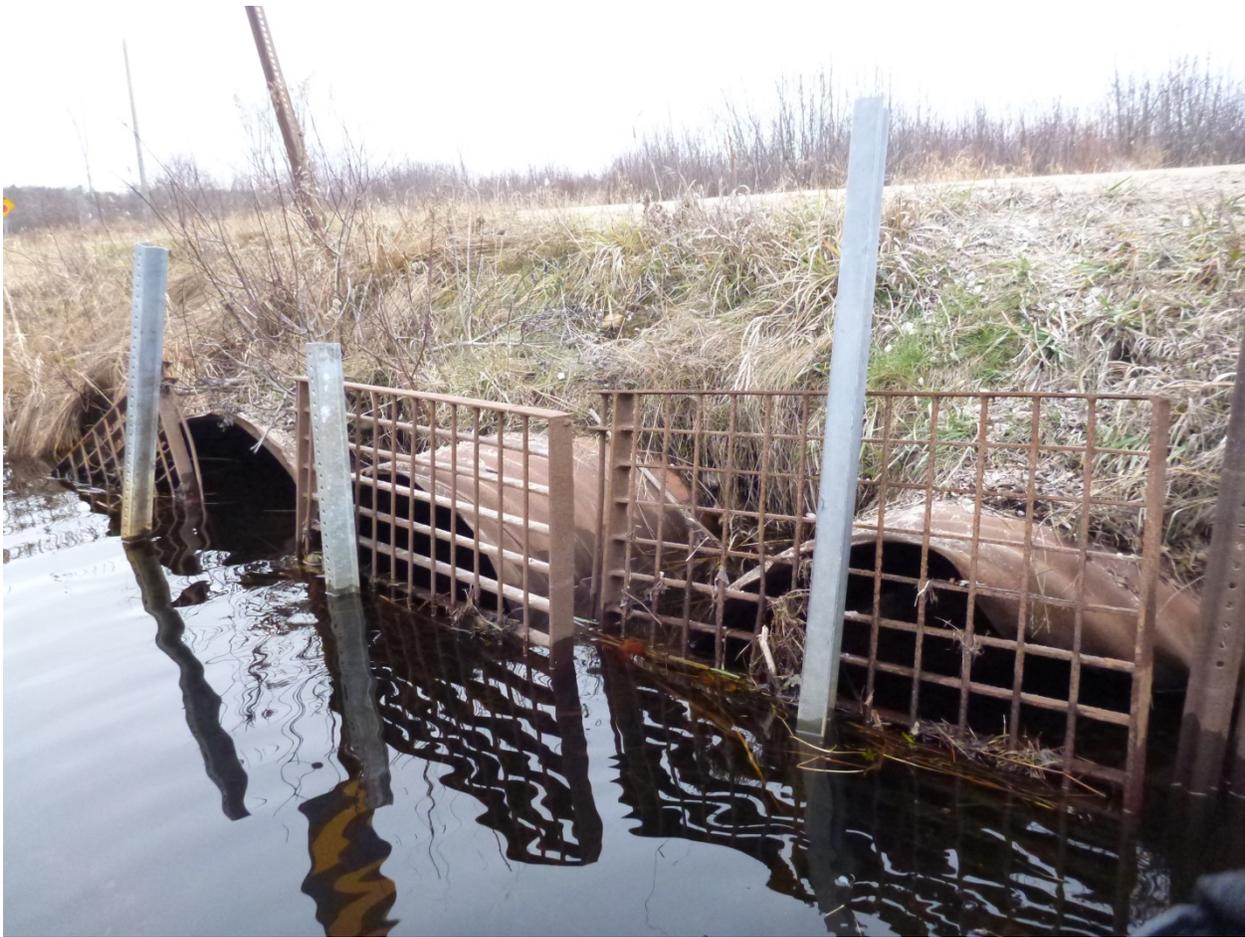
Current Conditions include three failing and undersized metal culverts and the gravel from the road surface is washing into the stream. The road width is narrow. Makeshift trash racks at the inlets are installed in an effort to prevent debris buildup inside the culverts.

- Erosion (tons/year): 6.3
- Fish Passage Determination: .9
- Extent of Erosion: Minor
- Severity Calculation: Severe

**Figure 6: Haymarsh Creek at Romaniak Rd. Stream inlet.**

- Replace three CMP culverts with new 18-foot span by 4-foot rise precast concrete box culvert. Pave approaches (100' each side of crossing). Locate new crossing just east of existing. Maintain flows through existing during construction. Temporary sheeting to isolate new culvert location during construction.

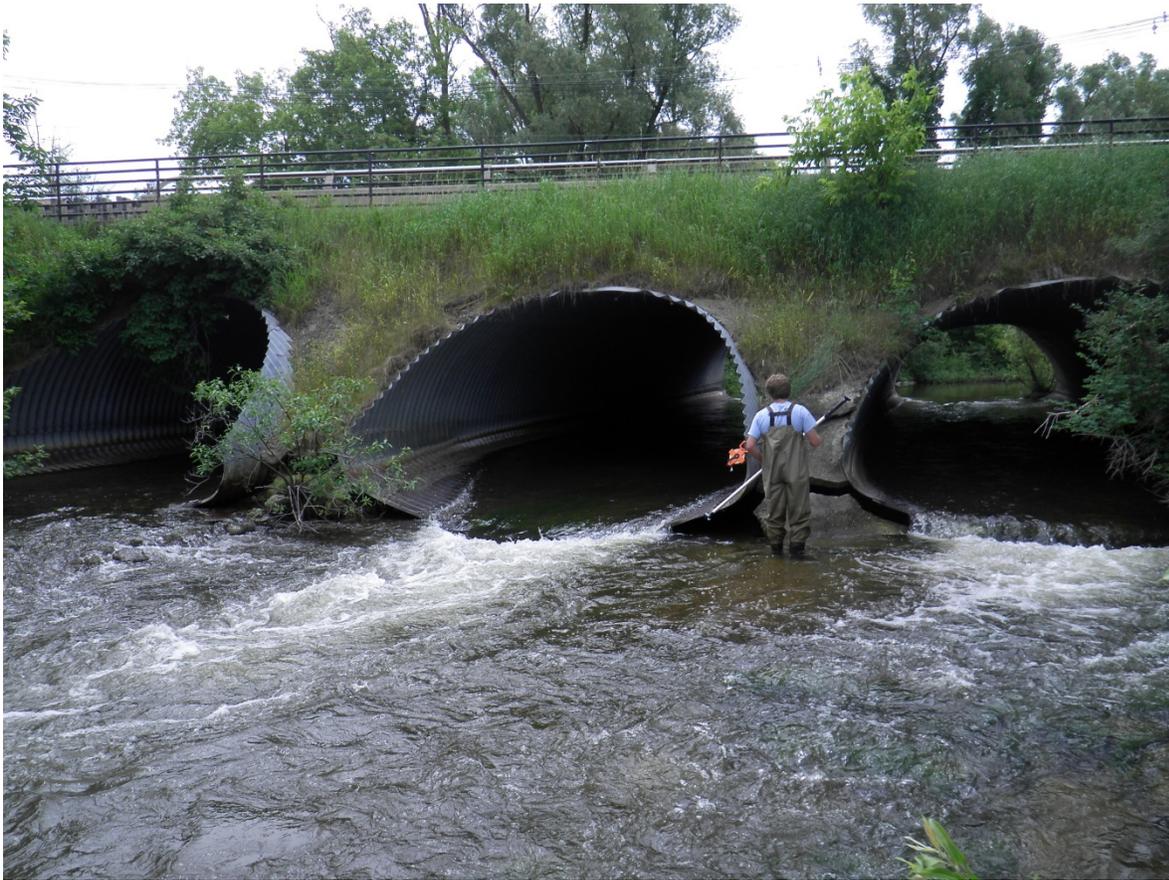
The three large culverts are perched (elevated) approximately 1' above the base stream flow. The culverts are also showing signs aging. The RSX is a popular paddling pull-out destination given its proximity to the City of Petoskey's Bear River Valley Recreation Area. Unfortunately, the conditions are less than ideal given the river's velocity downstream of the culverts, the sharp bend in the channel immediately following, and the protruding, mitered metal culvert ends.

- Erosion (tons/year): .013
- Fish Passage Determination: 0  
*Heather Hettinger, Michigan Department of Natural Resources Fisheries Biologist, noted that the RSX is a barrier to smaller fish species during low flows.*
- Extent of Erosion: Minor
- Severity Calculation: Severe

**Figure 7: Bear River at Sheridan St. Stream outlet.**

Proposed RSX Improvement: A clear-span timber bridge would allow passage of all fish species, prevent downstream scour and upstream flooding immediately around the crossing, and allow hydrologic processes to restore channel geomorphology.

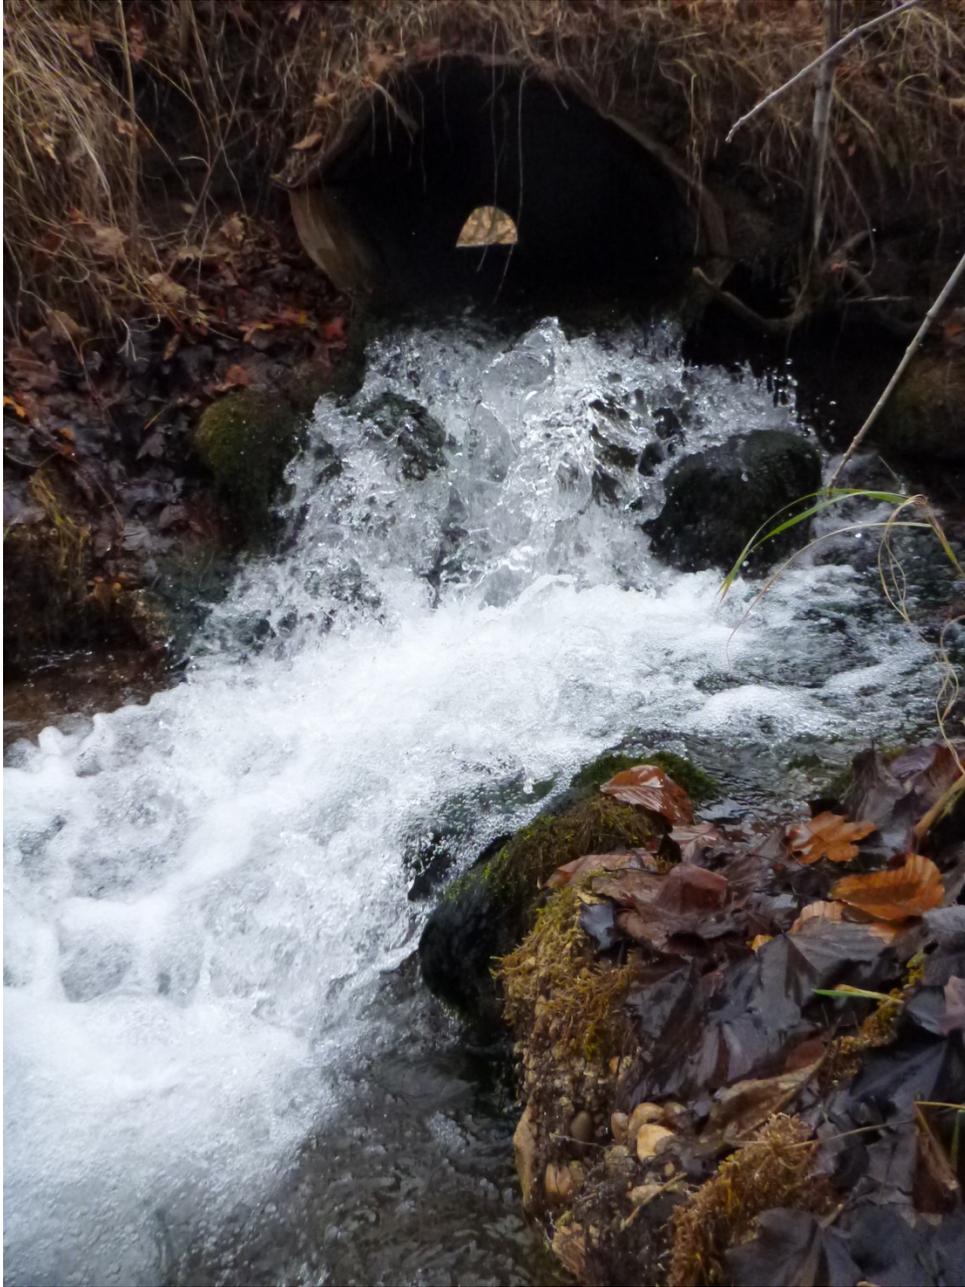
Current conditions include moderate localized erosion and a complete fish passage barrier. The undersized, perched and partially crushed culvert is in poor condition. Downstream, both streambanks are severely eroding due to the unstable hydrologic conditions created by the RSX.

- Erosion (tons/year): .26
- Fish Passage Determination: 0
- Extent of Erosion: Moderate
- Severity Calculation: Severe

**Figure 8: Tributary to Springbrook Creek at Slashing Road. Stream outlet.**

- Replace existing CMP culvert with new 87- by 63-inch diameter CMP arch culvert. Restore existing paved approaches (50' each side of crossing). Locate new crossing just north of existing. Maintain flows through existing during construction. Temporary sheeting to isolate new culvert location during construction.

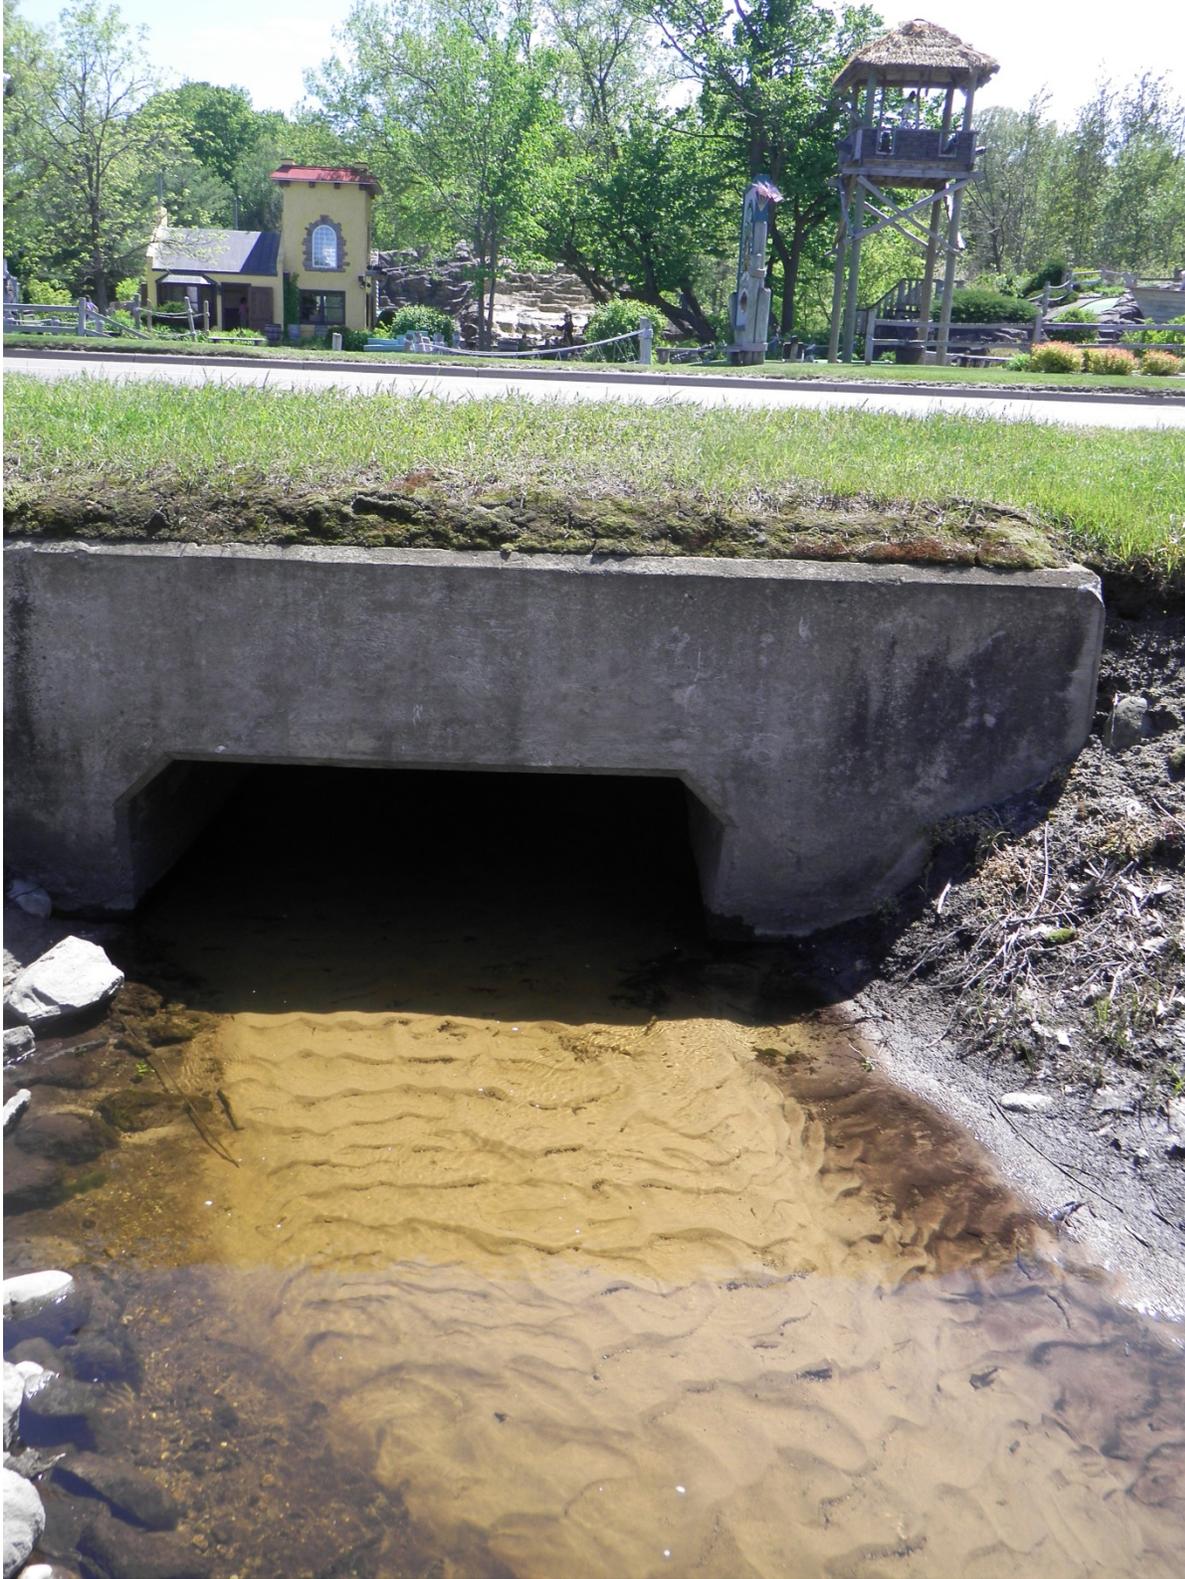
Current conditions in the area upstream of the RSX include regular and overwhelming flooding. Many of the commercial property owners have expressed great concern and invested resources into short-term fixes. Tip of the Mitt Watershed Council and Northwest Design Group have both conducted watershed studies to better understand the causes behind the flooding. Although results from these studies are not conclusive, the culvert may be undersized. According to a study performed by NDG (2004):

Furthermore, the accumulation of sediment from both upstream and localized sources at the RSX has likely reduced the capacity of the culvert, thereby exacerbating upstream and downstream problems.

**Figure 9: Tannery Creek at U.S. 31. Stream outlet.**

- The structure should be replaced with a larger box culvert. Exact dimension to be determined through modeling and engineering studies.

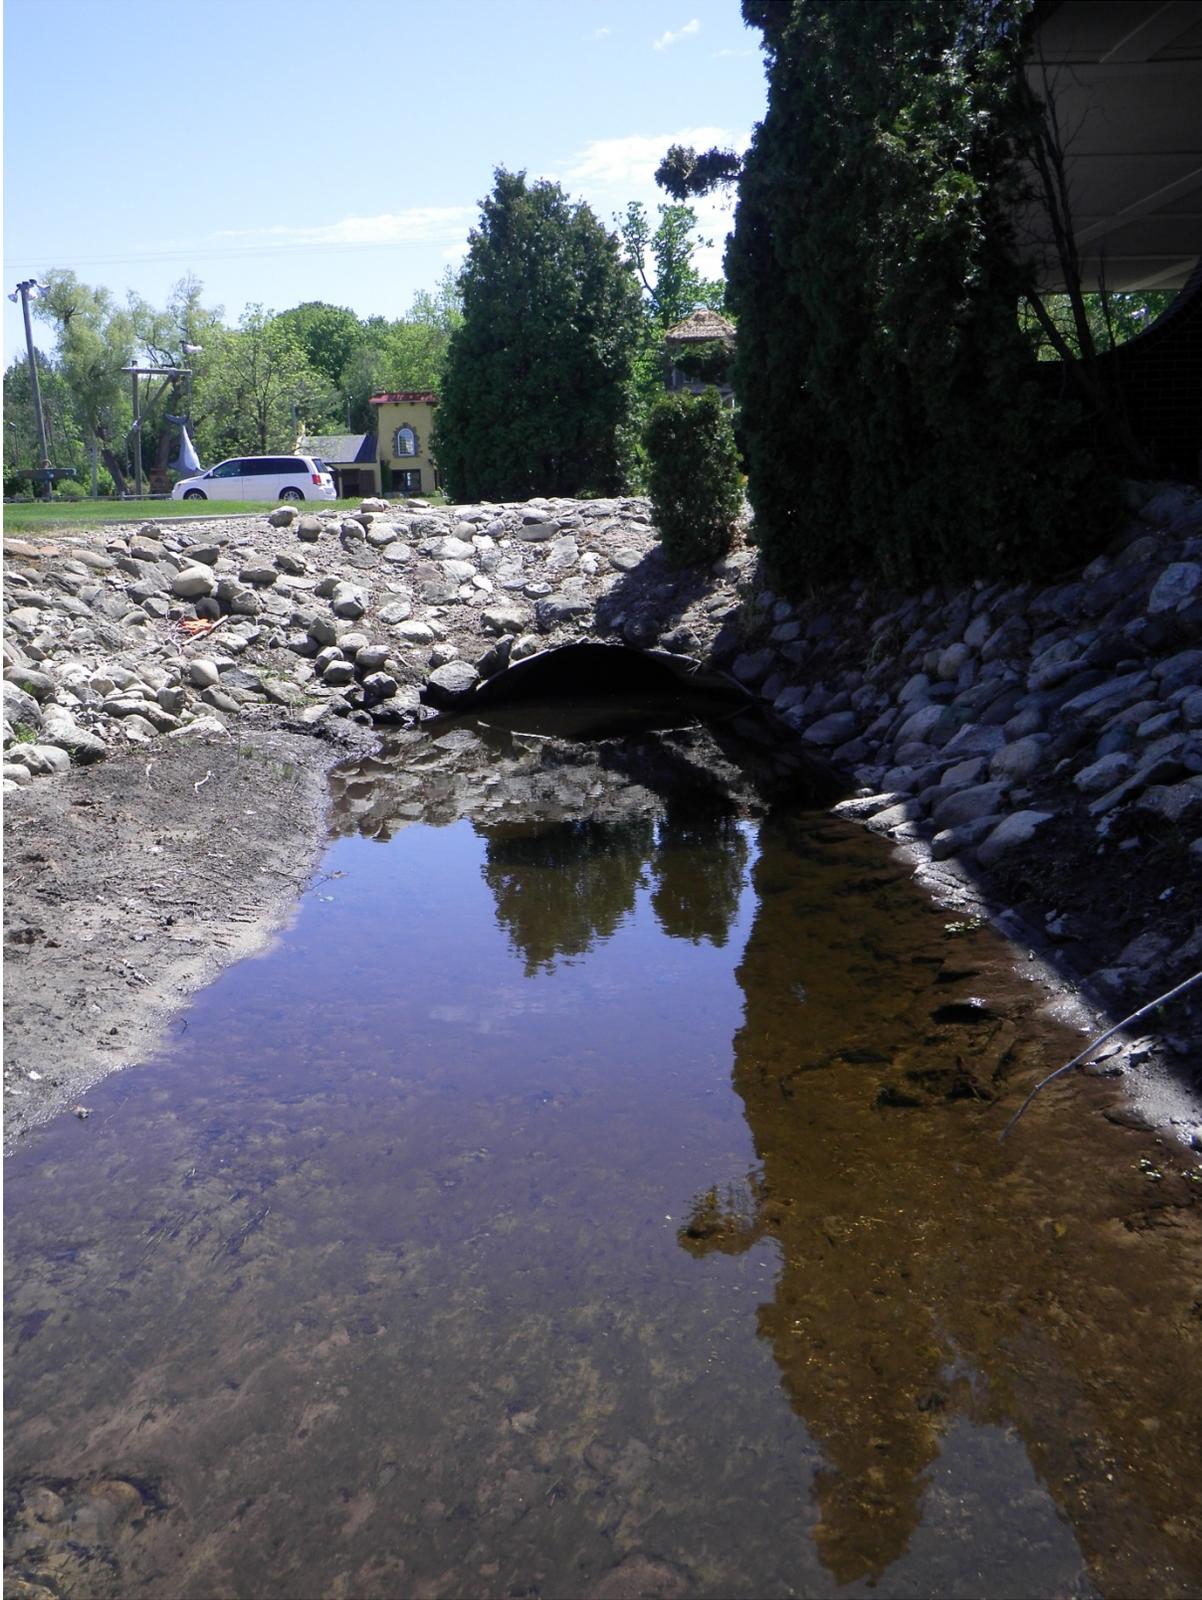
Current conditions of the RSX include an undersized culvert. The culvert is smaller than the preceding RSX (LTB 069), approximately 25 feet upstream. During rain events the area between culverts floods and the culverts are completely submerged. The asphalt drive-thru is immediately adjacent to the both the inlet and outlet of the culvert. Stormwater runoff drains directly into the stream.

**Figure 10: Tannery Creek at Chase Bank. Stream inlet.**

- The culvert should be replaced with a larger structure, equal to or larger in size than the U.S. 31 (LTB 069). The streambanks should be stabilized with vegetation to assist with filtration of the stormwater runoff. Drainage should be directed away from the RSX.
